FINAL REPORT

THE ACCIDENT INVESTIGATION

OF US BANGLA AIRLINES, BOMBARDIER (UBG-211), DHC-8-402, S2-AGU, AT
TRIBHUVAN INTERNATIONAL AIRPORT, KATHMANDU, NEPAL

ON 12 MARCH 2018

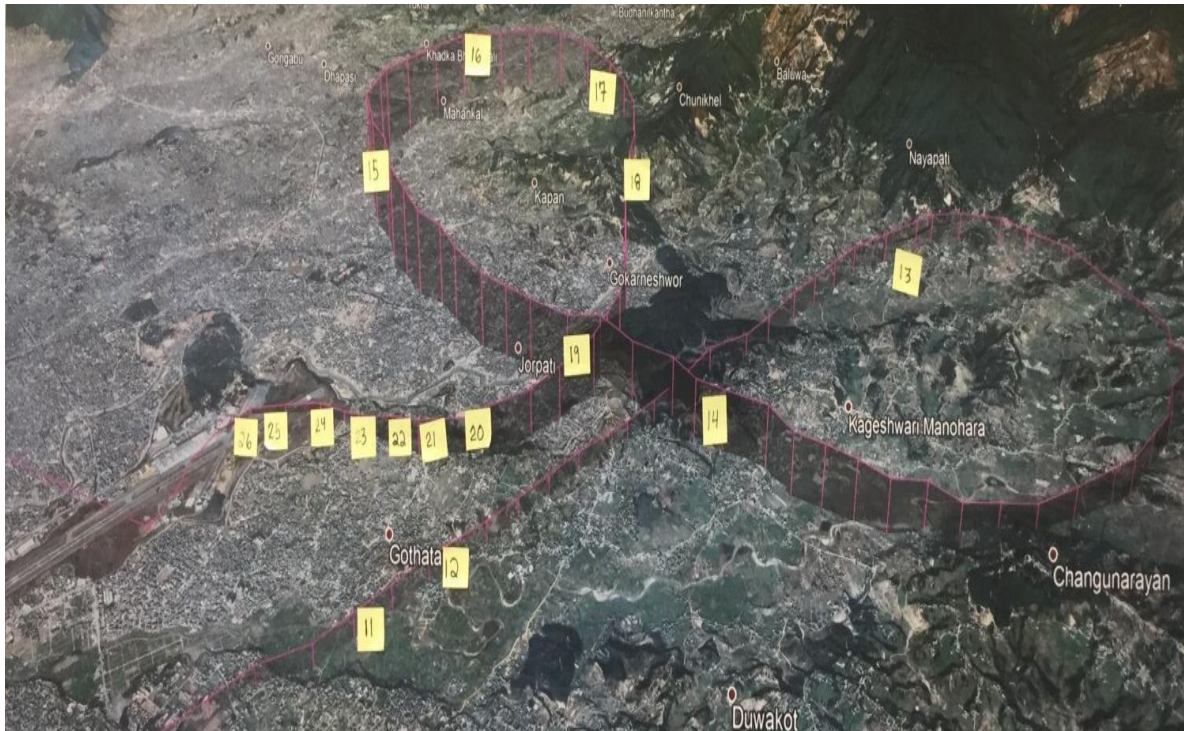
At around 0834 UTC the aircraft touched down at coordinates N27°41'48", E085°21'34", 1700 meters down the threshold with a bank angle of about 15 degrees and an angle of about 25 degrees with the RW axis (approximately heading Southeast) and on the left of the center line of RWY 20, then veered southeast out of the runway through the inner perimeter fence along the rough down slope and finally stopped at coordinates N27°41'41", E085°21'32" about 442 meters southeast from the first touchdown point on the runway. All four crew members (2 cockpit crew and 2 cabin crew) and 45 out of the 67 passengers onboard the aircraft were killed in the accident. Two more passengers succumbed to injury later in hospital during course of treatment. The aircraft caught fire after 6 seconds of touchdown which engulfed major portions of the aircraft.

(Aircraft Movement as depicted by the Animation based on DFDR Data)

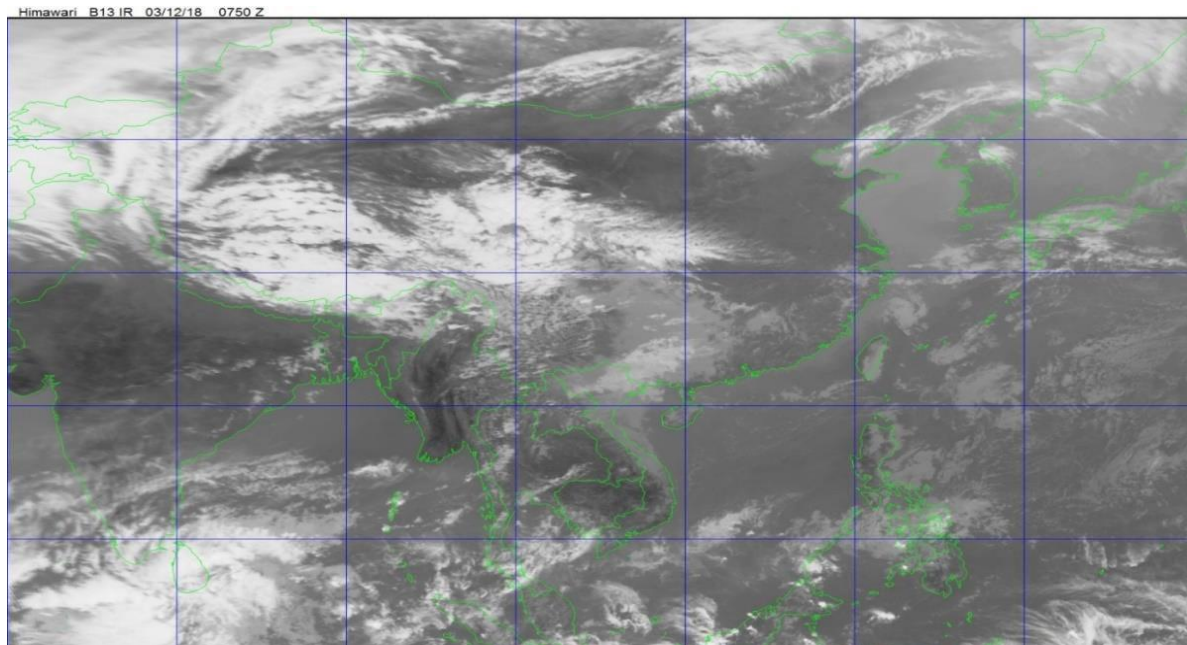
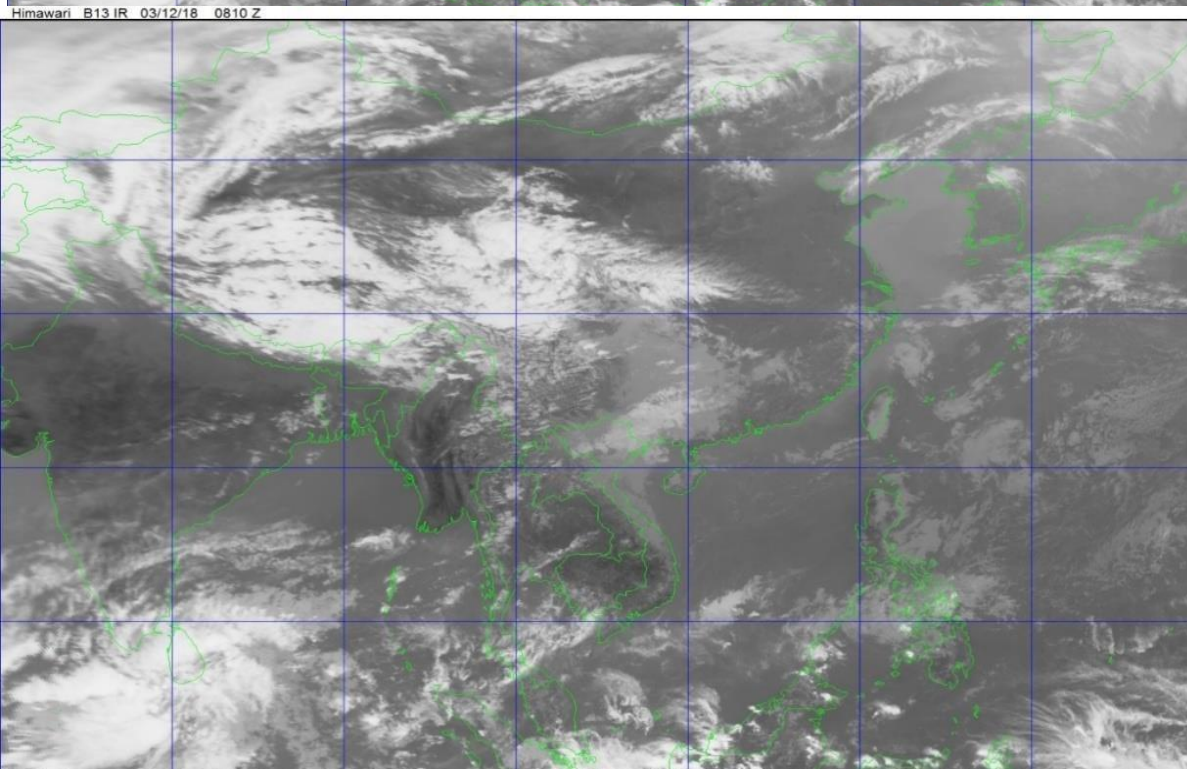
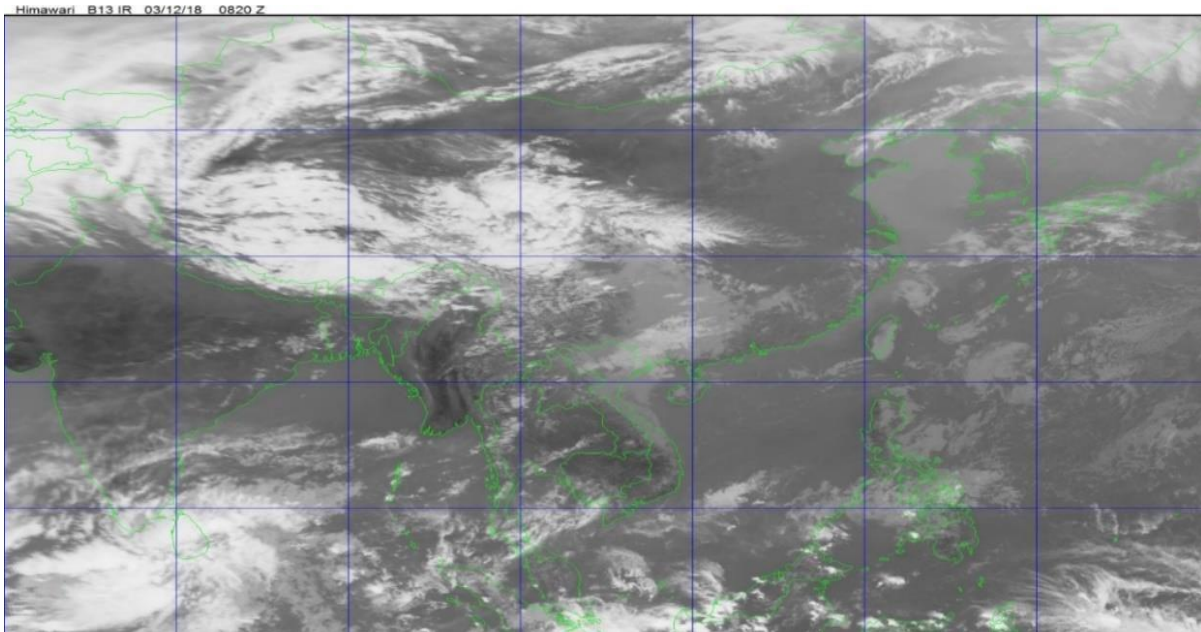
1.7.3 Satellite Images of Weather

- a. Wind: Westerly 07 to 08 kts.
- b. Visibility: 06 to 07 km.
- c. Cloud: Scattered (3-4 Oktas) low clouds and few (1-2 Oktas) cumulonimbus cloud
Cumulonimbus was observed towards Southeast, South and Southwest direction of Kathmandu valley.

- d. Temperature: 21⁰C.
- e. Meteorological Conclusion:
The sky was generally cloudy with cumulonimbus cloud seen towards southeast, south and southwest direction of the valley.

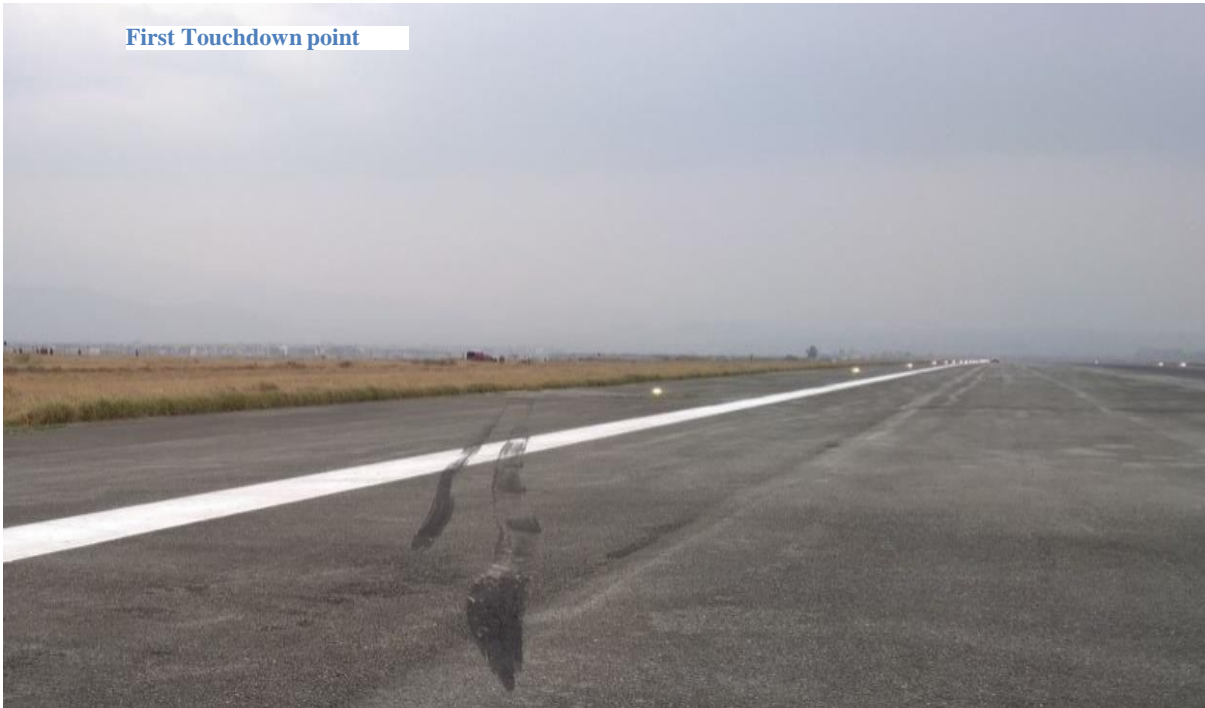
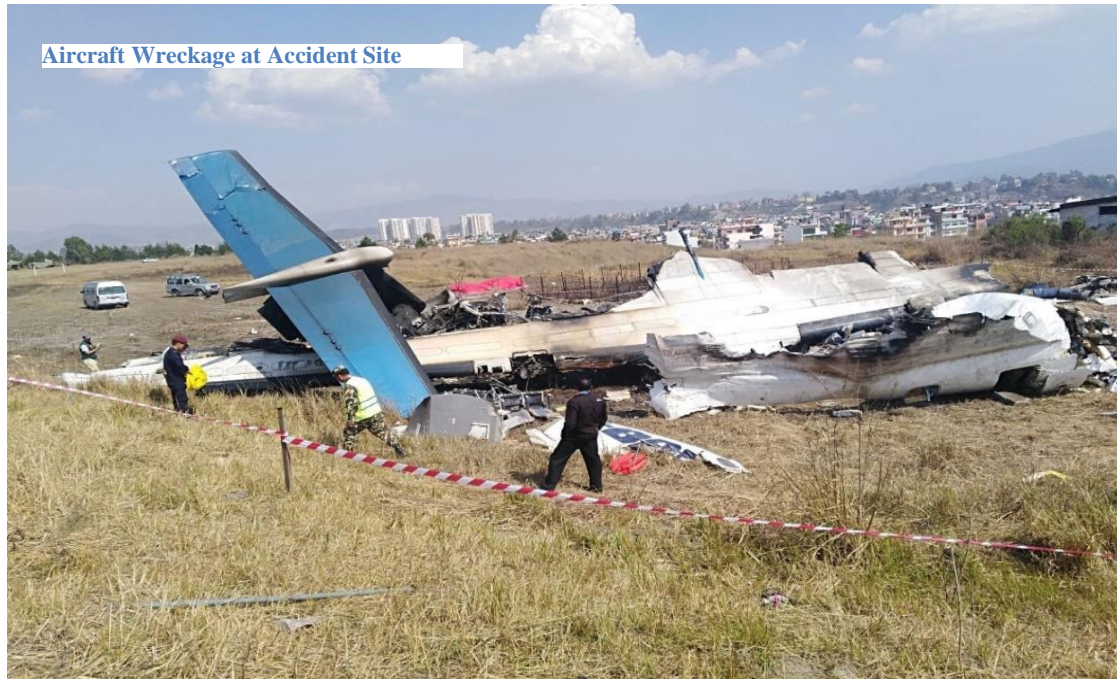
The aircraft touched down at coordinates N27⁰41'48", E085⁰21'34", 1700 meters down the threshold and on the left of the center line of Runway 20, then veered southeast out of the runway through the inner perimeter fence along the rough down slope and finally stopped at coordinates N27⁰41'41", E085⁰21'32" about 442 meters southeast of the runway.

The aircraft was fragmented into number of debris along the rough down slope before coming to a stop. Engines, APU, landing gears were almost detached from the aircraft; wings were broken and most of the aircraft parts were damaged due to post crash fire.
